# The Analysis of Light-duty Truck Diesel Engine Crankshaft Failure

In this study, crankshaft failure of four-cylinder light-duty truck diesel engine was examined. The failure occurred by fatigue crack growth which was initiated from a surface defect after about 95000 km on the second crankpin from the crankpin-web fillet where the stress concentration was at the highest level. To evaluate the mechanical properties, some hardness and tensile tests were conducted and spectrometry analysis was used for studying the chemical composition of the crankshaft material. Additionally, for considering and evaluating the microstructure, microcracks, fracture surface, and the cause of failure, optical microscopy (OM) and scanning electron microscopy (SEM) equipped with energy dispersive spectrometry (EDS) were used. The morphology of the fracture surface showed a smooth and flat crack initiation with the beach marks and ratchet marks and second crack propagation zone with beach marks and fast final fracture zone near the end. The results of EDS observations indicated that inclusions of non-metallic aren't distributed throughout on the steel and in some places leads to the formation of the micr

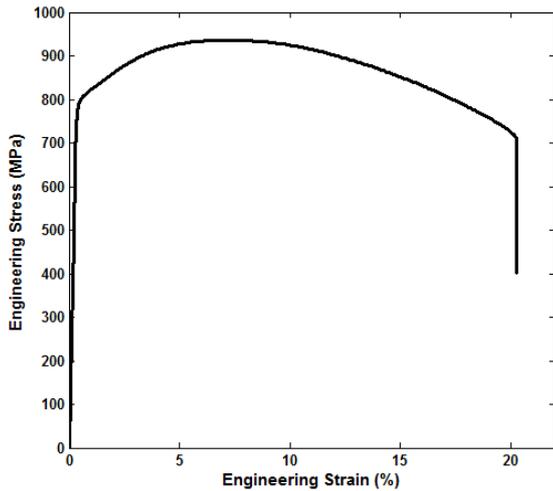
The mechanical properties of DIN 1.7225 used in the present crankshaft and standard alloy are listed in Table 4 and the engineering stress vs. engineering strain curve of crankshaft material is drawn in Fig.3.

**Fig. 3.** Engineering stress vs. engineering strain curve of crankshaft material.

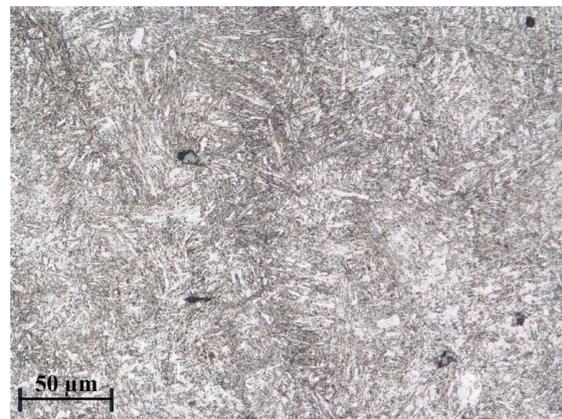
First a cross-section area of crankshaft crankpin with thickness of 15 mm was cut and machined on both sides. Then the surface of the sample was treated by sandpapers (from No. 60 to 1200). The polishing on the surface of the sample was done by diamond paste. Finally, to reveal microstructural feature of the sample, it was etched by 2% Nital. Fig. 4 displays micrograph of the crankpin No. 2 on the outer surface. It also

shows tempered martensite steel which has the inclusion having the average size of around 10µm.

**Fig. 4.** Micrograph of crankpin material with 500× magnification.

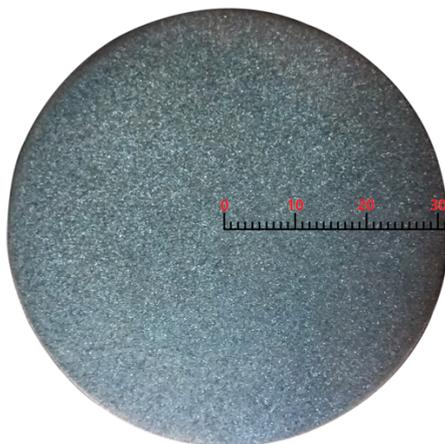
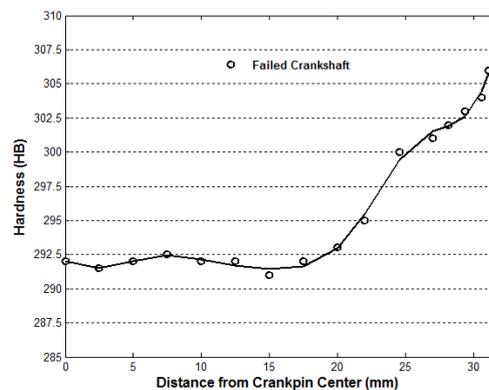
In Fig. 5, the hardness profile that is plotted up on the outer surface; as the graph reaches to the outer surface, the hardness increases. This behavior is related to the effect of surface hardness heating treatment done on cementation steels. To accomplish heating treatment and quenching steel in oil, carbides and martensite phases are formed on the sample surface while there are soft phases in the crankpin center. Thus, the presence of the hard phases on the outer surface of the crankpin causes increase in hardness from the center to the outer surface.

**Fig. 5.** Hardness distribution from center to outer diameter of the crankpin.

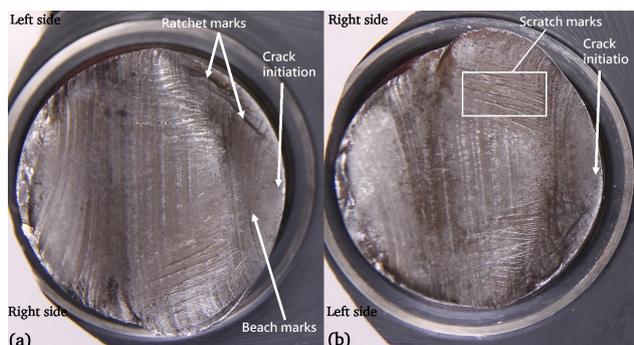
Fig. 6 displays the two surfaces of the fractured second crankpin, which fit together. The morphology of the fracture surface shows a smooth and flat crack initiation with the beach marks and ratchet marks and second crack propagation zone with beach marks and final fast fracture zone near the end. According to the beach marks orientation, it can be concluded that fracture starts from the crankpin-web fillet of crankshaft shown in Fig. 6 by arrow. Such cracks were initiated in the crankpin-web fillet zone which caused the premature fracture of crankshafts. This event has been referred to in the Refs. [7,9]. In addition, some scratch marks on the fracture surface shown in Fig. 6 is because of friction and striking between the two fracture surfaces after crankshaft break.

**Fig. 6.** The fractured surfaces of the crankshaft at the second crankpin.

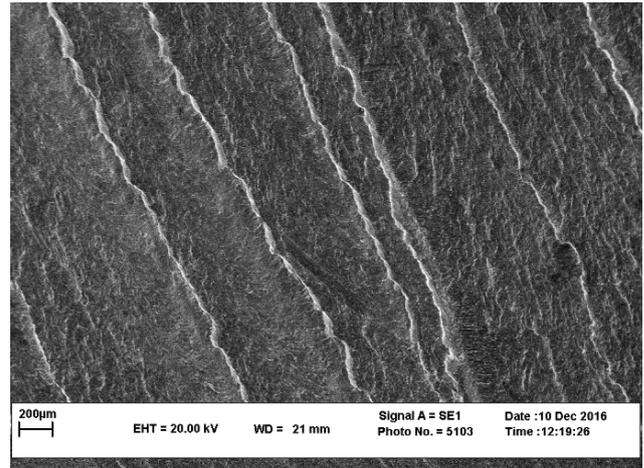
SEM secondary electron image (Fig. 7) and SEM backscattered electron image (Fig. 8) were taken so as to carefully examine the origins of the cracks of fracture surfaces with 100x magnification. The images show some defects and microcracks at crack initiation. Within the crack, large microcrack clusters, typically 0.1-0.3 mm in size, and many smaller microcracks are observed (Figs. 7-10). EDS was provided for two microcracks and their surrounding areas to examine the origins of the microcracks. Microcracks having these composed elements showed the non-metallic inclusions which is rich in sulfur (S), phosphor (P), and oxygen (O) while the background doesn't include such elements (Fig. 9 and Fig. 10). Like-type inclusions were observed in the forged steel used in gas turbine part [20] and in the steel (42CrMo4) bar used in automotive applications [21].

**Fig. 7.** SEM secondary electron image.

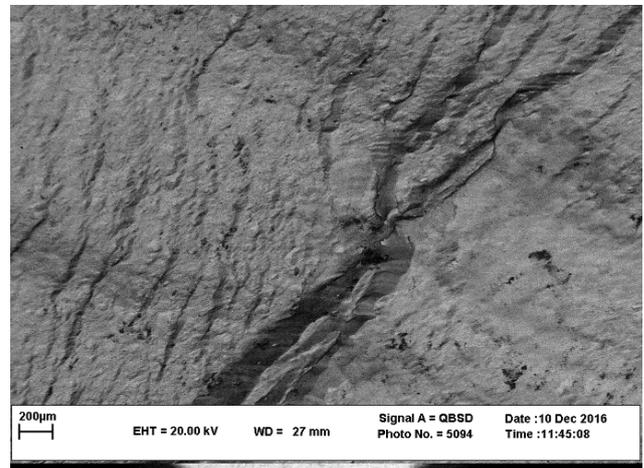
**Fig. 8.** SEM backscattered electron image.

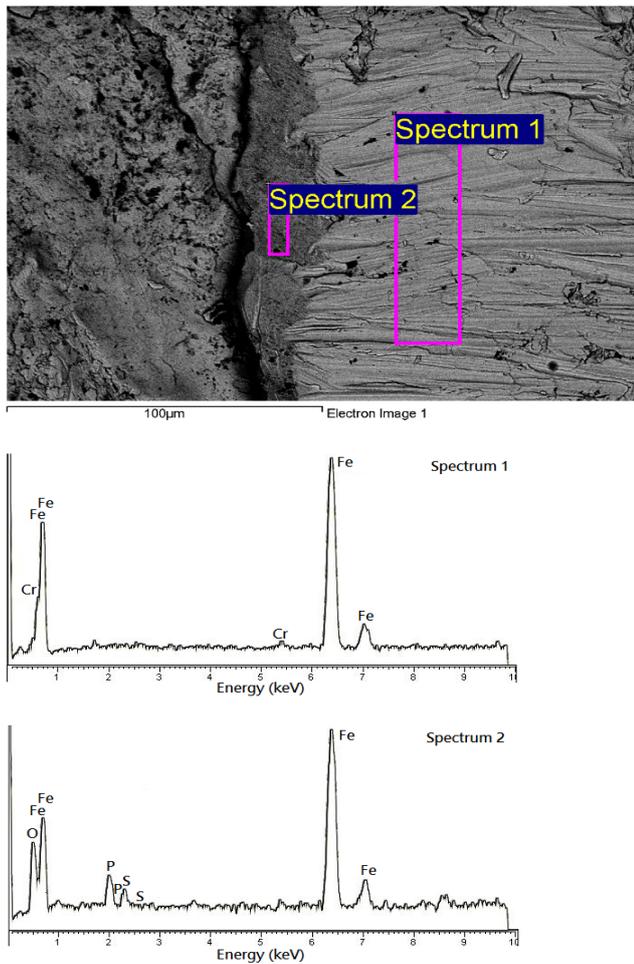
**Fig. 9.** Micrographs of the 2nd crankpin obtained from the right crack propagation for 1000x magnifications.

Figs. 9b and 10b clearly show the fact that the increase in P and S is considerably in the microcrack starting point. The presence of these elements on grain boundary causes the embrittlement of the material and crack propagation. Due to the high bending load caused by combustion pressure of engine, there is the possibility of crack growth in crankshaft. If the content of sulfur (S) is in range of 0.035 to 0.05 wt%, it will be useful for steel machining and if it is greater than the given range, there is a higher the possibility of crack formation. The high amount of phosphor in the range of 0.04% makes the steel brittle [24]. The results of EDS observations showed that inclusions of non-metallic arent distributed throughout on the steel and in some places leads to the formation of the microcrack clusters.

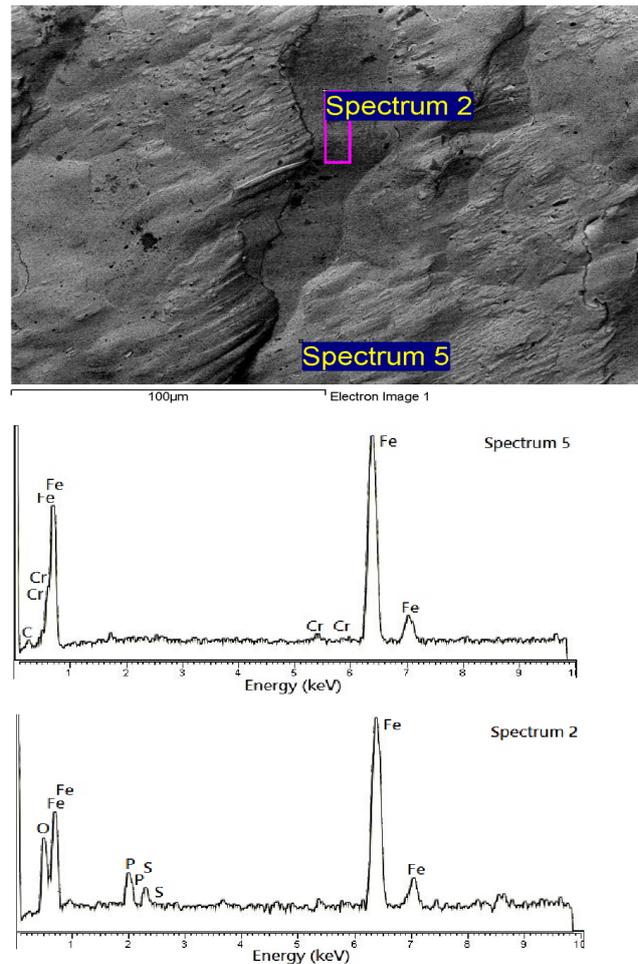
**Fig. 10.** Micrographs of the 2nd crankpin obtained from the left crack propagation for 1000x magnifications.
